# Manhole Inspection Summary

Manhole # S39I\_\_023MH

Insp Date: **8/19/08 11:26 AM**

**Location** Address: **701 pratt st**

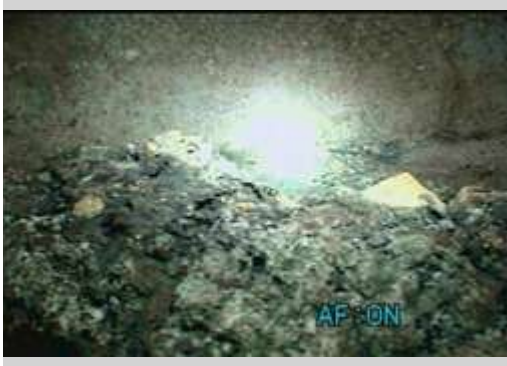
Defect 2

Condition: ☐ Sound ☐ Cracked ☐ Root Intrusion ☐ Deteriorated ☐ Leaks ☒ **Debris**

bench debris

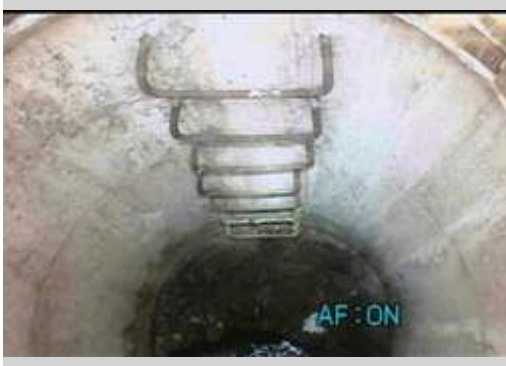
Defect 1

**Steps** Count: **7** Missing: **0** ☒ **Corroded**

corroded steps

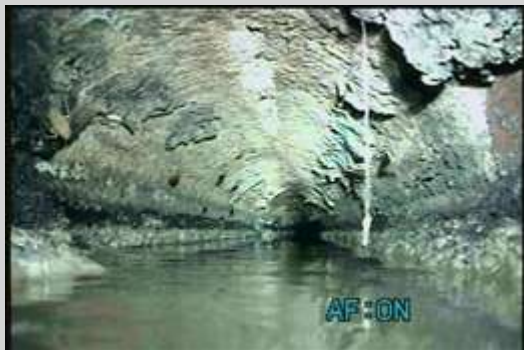
12 O'Clock Outflow

Deposits: ☐ None ☐ Mud ☒ **Sludge** ☐ Debris ☐ Grease

Silt Depth: 0 (in.) Deposits Extent: **Light**

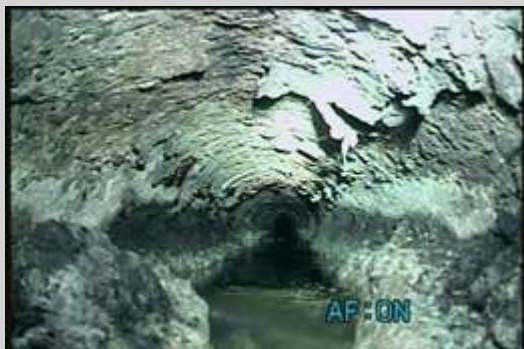
3 O'Clock Inflow

Deposits: ☐ None ☐ Mud ☒ **Sludge** ☐ Debris ☐ Grease

Silt Depth: 0 (in.) Deposits Extent: **Medium**
